UV Curing of Complex Three Dimensional Objects

Test results from an exposure evaluation of Altec Carlisle Brake Shoes:

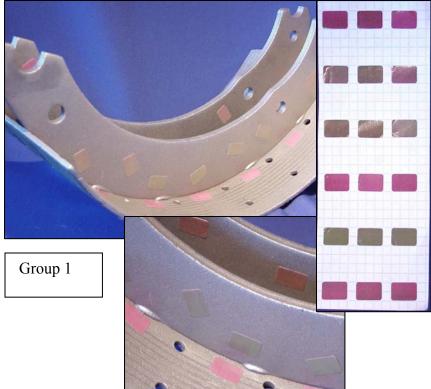
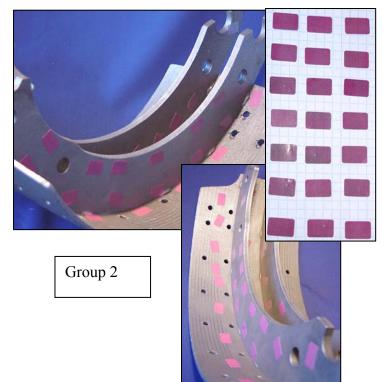
Detail of Group 1:

In the first test, we ran the brake shoe at an angle perpendicular to the light path. As clearly indicated by the UV Intensity Labels; the various planes on this three dimensional object received very uneven UV exposure. Pictured is a full view, a close up view, and finally we also removed the labels and placed them onto a sheet for easy analysis. Each horizontal row on the sheet contains labels from a different plane on the object.

We applied Intensity Labels to the vertical and horizontal planes on the most complex side of the brake shoe. These surfaces included both the outer planes and the more difficult, shadow prone inner planes. We then ran the brake shoe through the path of the curing system. We performed three separate tests; one with the vertical planes parallel to the energy, another with the vertical planes perpendicular to the energy, and a final test with the vertical planes at a 45 degree angle to the energy. Upon close inspection, the following results were documented.
